## **Report about the Protection and the Conservation Conditions of Wooden Monuments in the Czech Republic**

**Helena Zemánková, Zuzana Jacková, Bohumil Štraka,  
Jan Vaněrek, Petr Hradil, Josef Hrabec, Ivana Žabičková**  
Faculty of Architecture, Brno University of Technology

The research of wooden churches has been conducted within the EU Culture 2000 project entitled "Rescuing hidden European wooden religious heritage: an international methodology for implementing a database for restoration projects" (Project CLT2005/A1/CH/IT-242) in the winter and spring of 2005/2006.

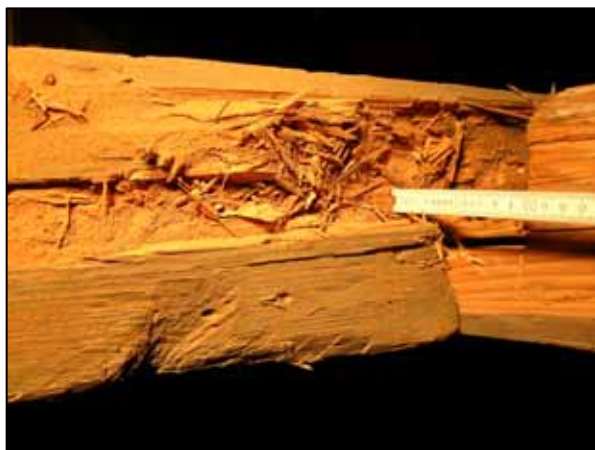
**7.** Surface damage by wood attack insects, 50 mm depth, Church Prašivá

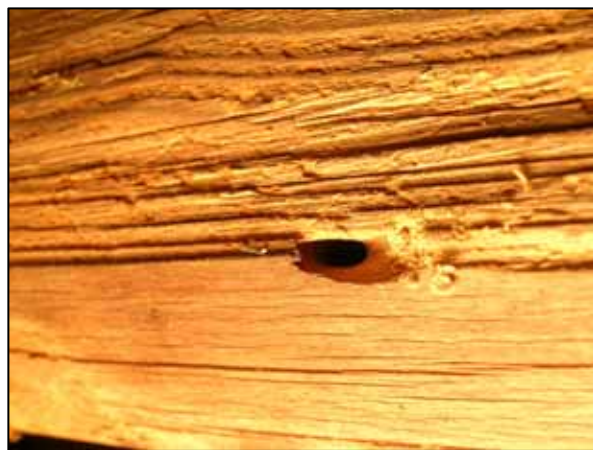
**8.** Typical oval emergence hole from the longhorn beetle (*Hylotrupes bajulus*), Church Prašivá

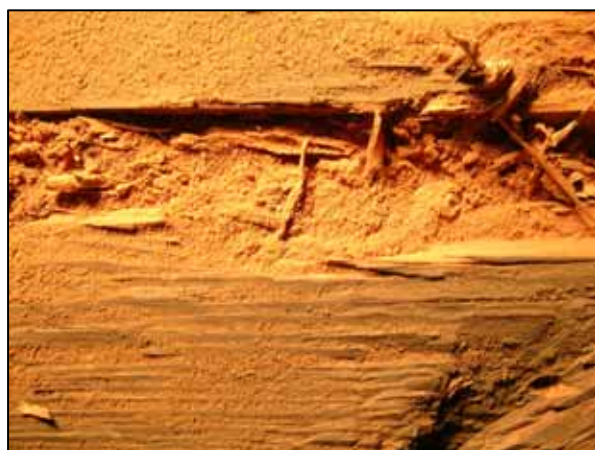
**9.** Wood damage on surface by insects, existing the bore dust, Church Prašivá

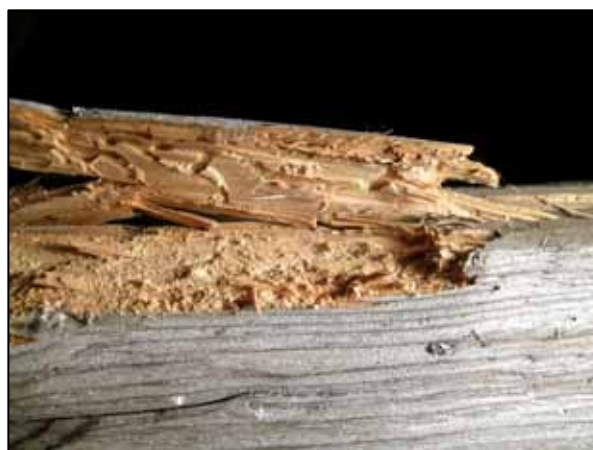
**10.** Wood damage on surface by insects, existing the bore dust, tunnels, Church Prašivá

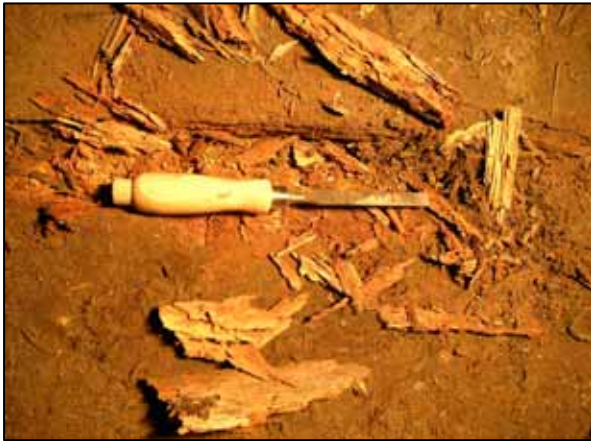
**11.** Damage of decking of ceiling by insects, Church Prašivá

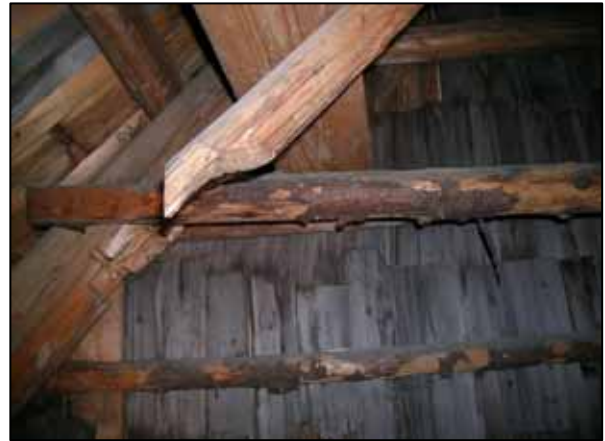
**12.** Presence of using the un-barked elements in the roof construction, Church Prašivá

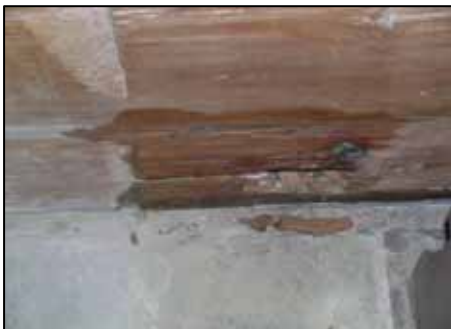
**13.** Water leaking over the wooden wall frame, Church Albrechtice

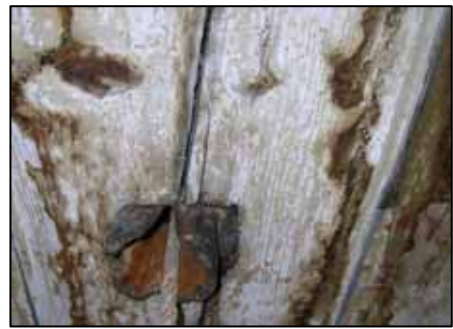
**14.** Water leaking into the ceiling construction, presence of wood insects' circular emergence holes from *Anobiidae*, Church Sedliště

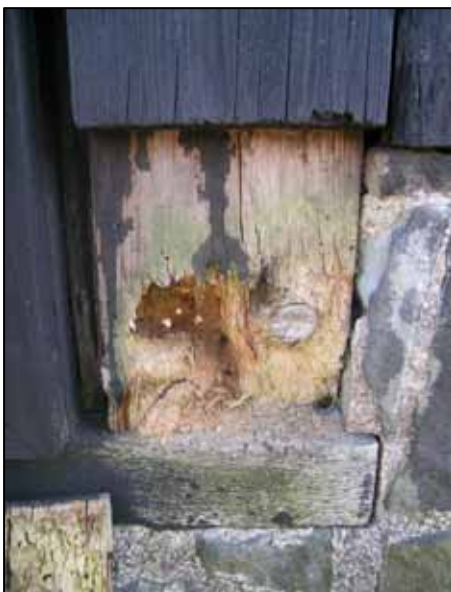
**15.** Wood degradation by brown rot fungi, Church Albrechtice

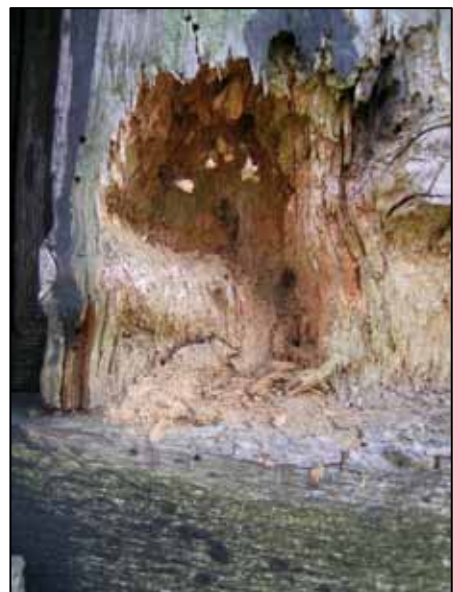
**16.** Detail of wood degradation by brown rot fungi, Church Albrechtice

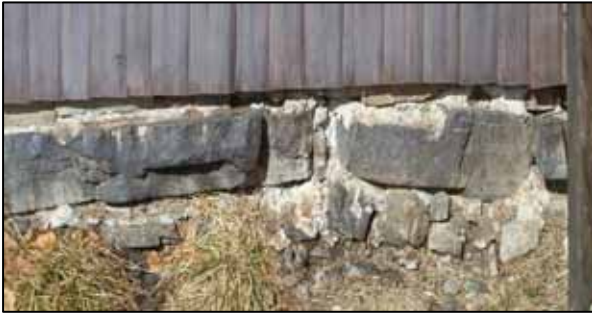
19. Socle of free-laid stones, recently sealed with cement grout.
