## **Report about the Protection and the Conservation Conditions of Wooden Monuments in the Czech Republic**

**Helena Zemánková, Zuzana Jacková, Bohumil Štraka,  
Jan Vaněrek, Petr Hradil, Josef Hrabec, Ivana Žabičková**  
Faculty of Architecture, Brno University of Technology

The research of wooden churches has been conducted within the EU Culture 2000 project entitled "Rescuing hidden European wooden religious heritage: an international methodology for implementing a database for restoration projects" (Project CLT2005/A1/CH/IT-242) in the winter and spring of 2005/2006.

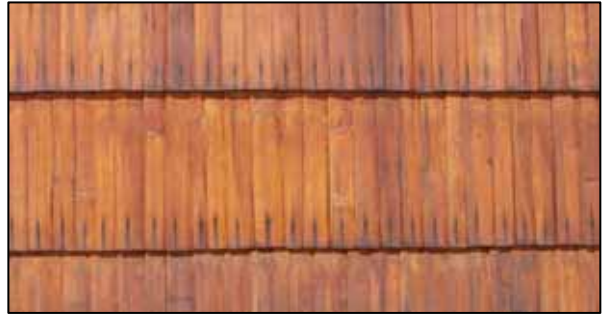
20. Timber walls of hewn timber or round logs covered with shingles.

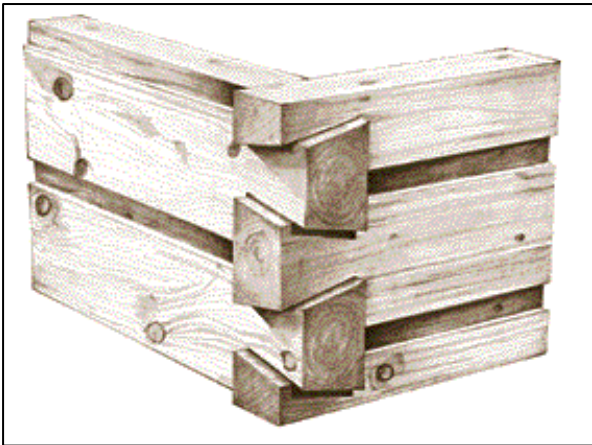
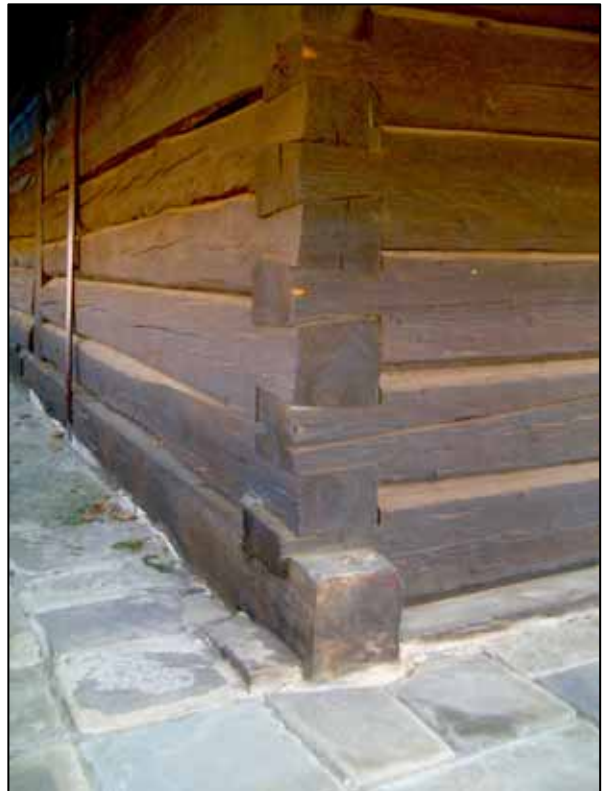
21, 22. Typical dovetail corner joints were used for the connection of wall joists.

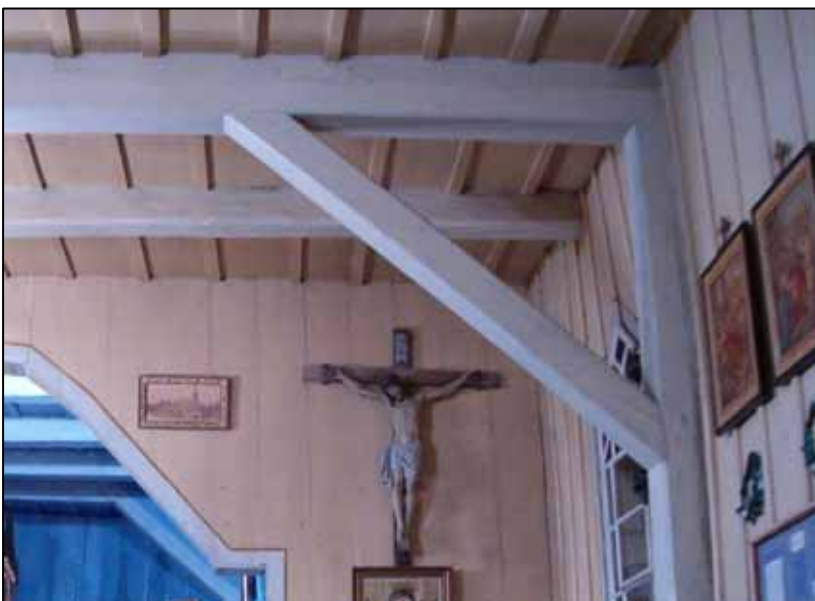
23. Joist ceiling is supported by walls and columns with struts. Beams are also members of roof structure. Several beams are doubled.

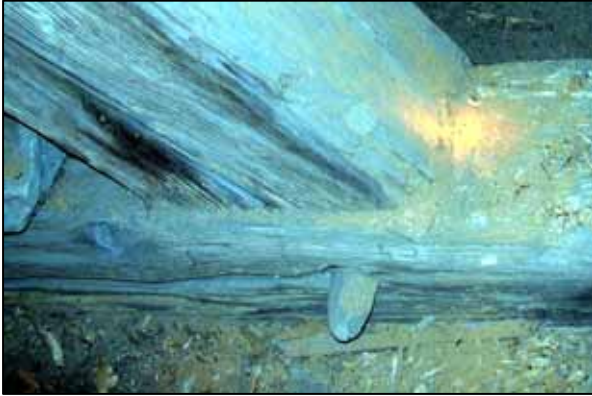
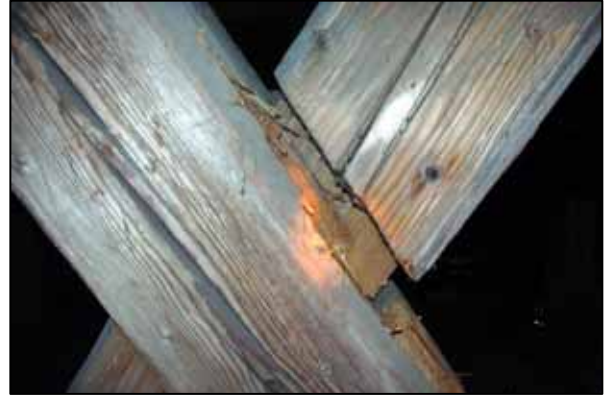
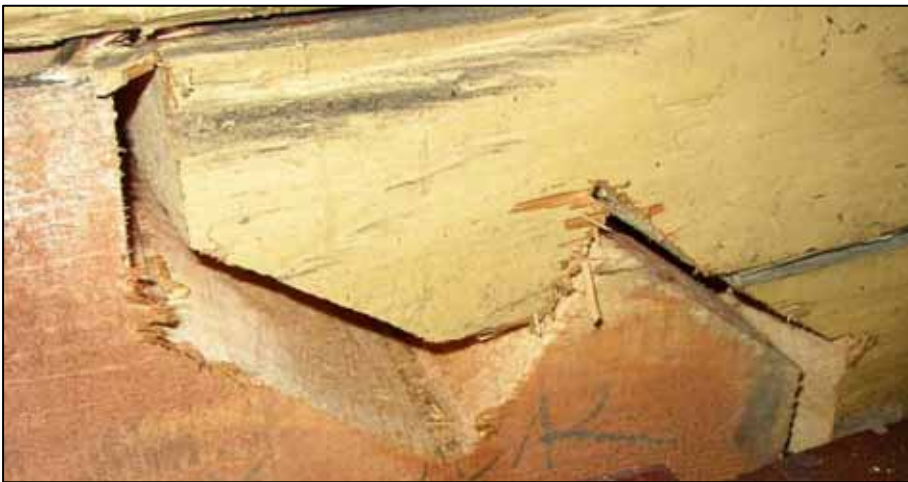
**24.** Rafters are connected to joist and one or two collar beams. They are supported by columns in principal trusses. Members are overlapped with notched connections with wooden dowels. The detail of mortise and tenon column connection is shown in the figure.
